# NORTH CAMBRIDGE FLOOD RECONNAISSANCE STUDY

May 18, 2000

*PREPARED FOR: ALEWIFE NEIGHBORS INC.  
CAMBRIDGE, MASSACHUSETTS*

*JACOBS CONSULTING SERVICES  
33 CLARK ROAD, NO. 1  
BROOKLINE, MASSACHUSETTS 02445*

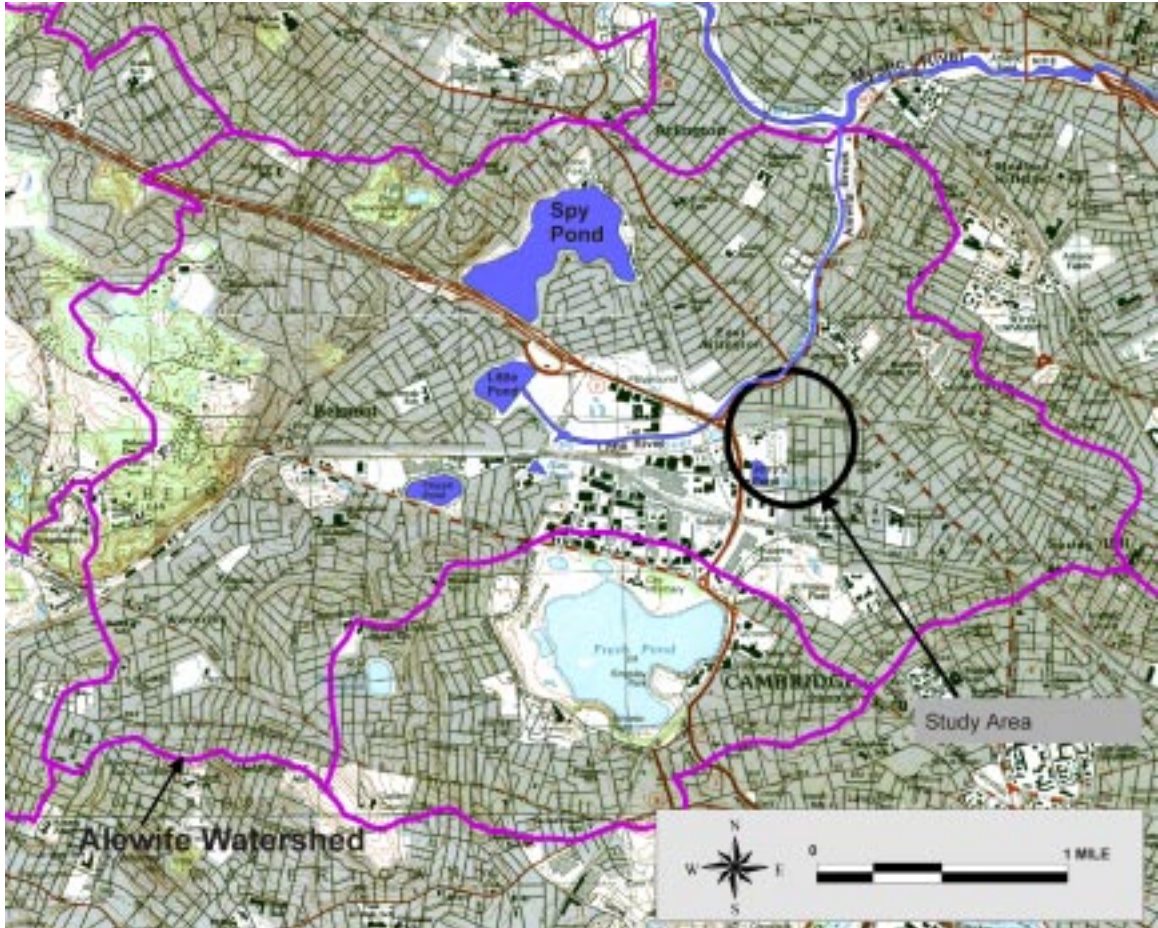
Figure 1. Study area.

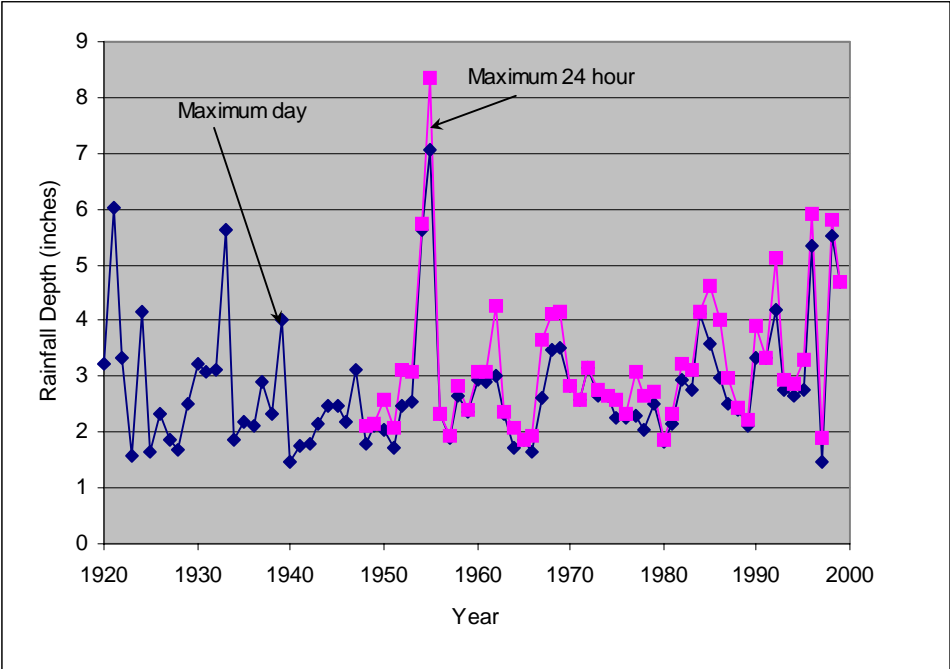
Figure 2 shows the Boston Logan Airport annual maximum daily precipitation depth for the period 1920-1999 (daily rainfall data from Northeast Regional Climate Center) and the annual maximum 24-hour precipitation depth for the period 1948-1999 (hourly rainfall data from National Climatic Data Center). The storm of record was caused by Hurricane Diane on August 18-19, 1955. The total rainfall for the two-day storm exceeded 11 inches, while exceeding 8 inches over the maximum 24-hour period within the storm.

Figure 2. Annual maximum precipitation recorded at Boston Logan Airport.

The absence of significant extreme events during the 1960's and 1970's evident in Figure 2 and Table 1 is consistent with trends in the frequency of hurricanes predicted by atmospheric scientists and reported in the popular press (US New and World Report, 1999). Todd Kimberlain of the National Oceanic Atmospheric Agency's National Hurricane Center was reported to say, “We appear to be entering a whole new era of hurricane activity.” Kerry Emanuel of Massachusetts Institute of Technology commented that “the dry spell since the 1960's has lulled people into a false sense of security.”

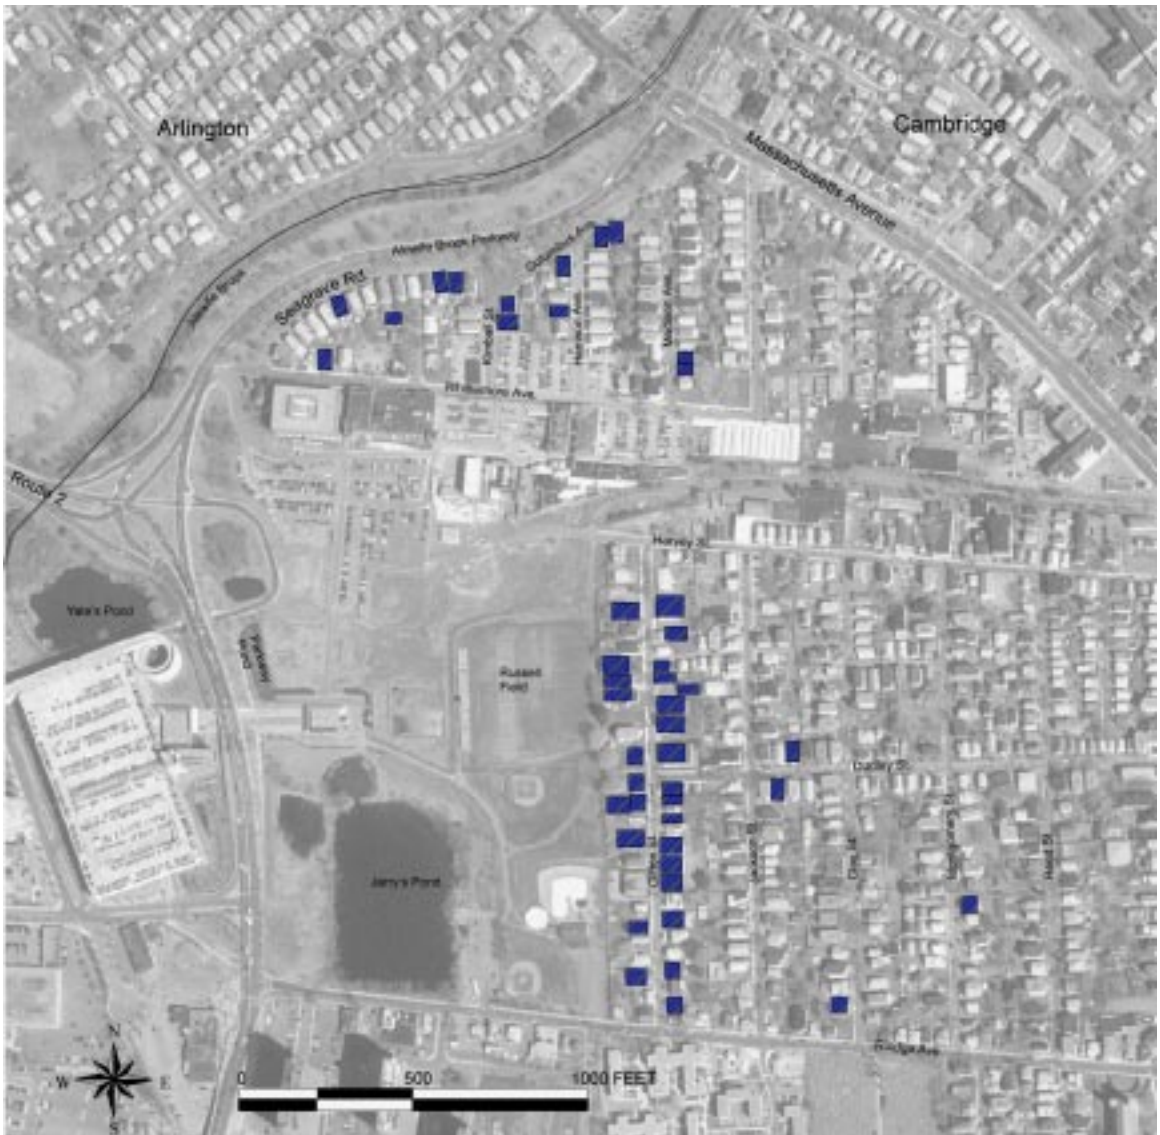
A survey was distributed by ANI in the N. Cambridge neighborhood to gather information on neighborhood flooding and flooding mechanisms. Figure 4 shows the location of surveyed homes. Responses were collected during both door-to-door canvassing and by email. As is evident from Figure 4, some blocks had more survey responses than others due to the limited resources of ANI. In other cases homeowners were unavailable or refused to cooperate due to fears that the published survey results would reduce neighborhood or individual property values. Since the survey results

Figure 4. Location of surveyed homes

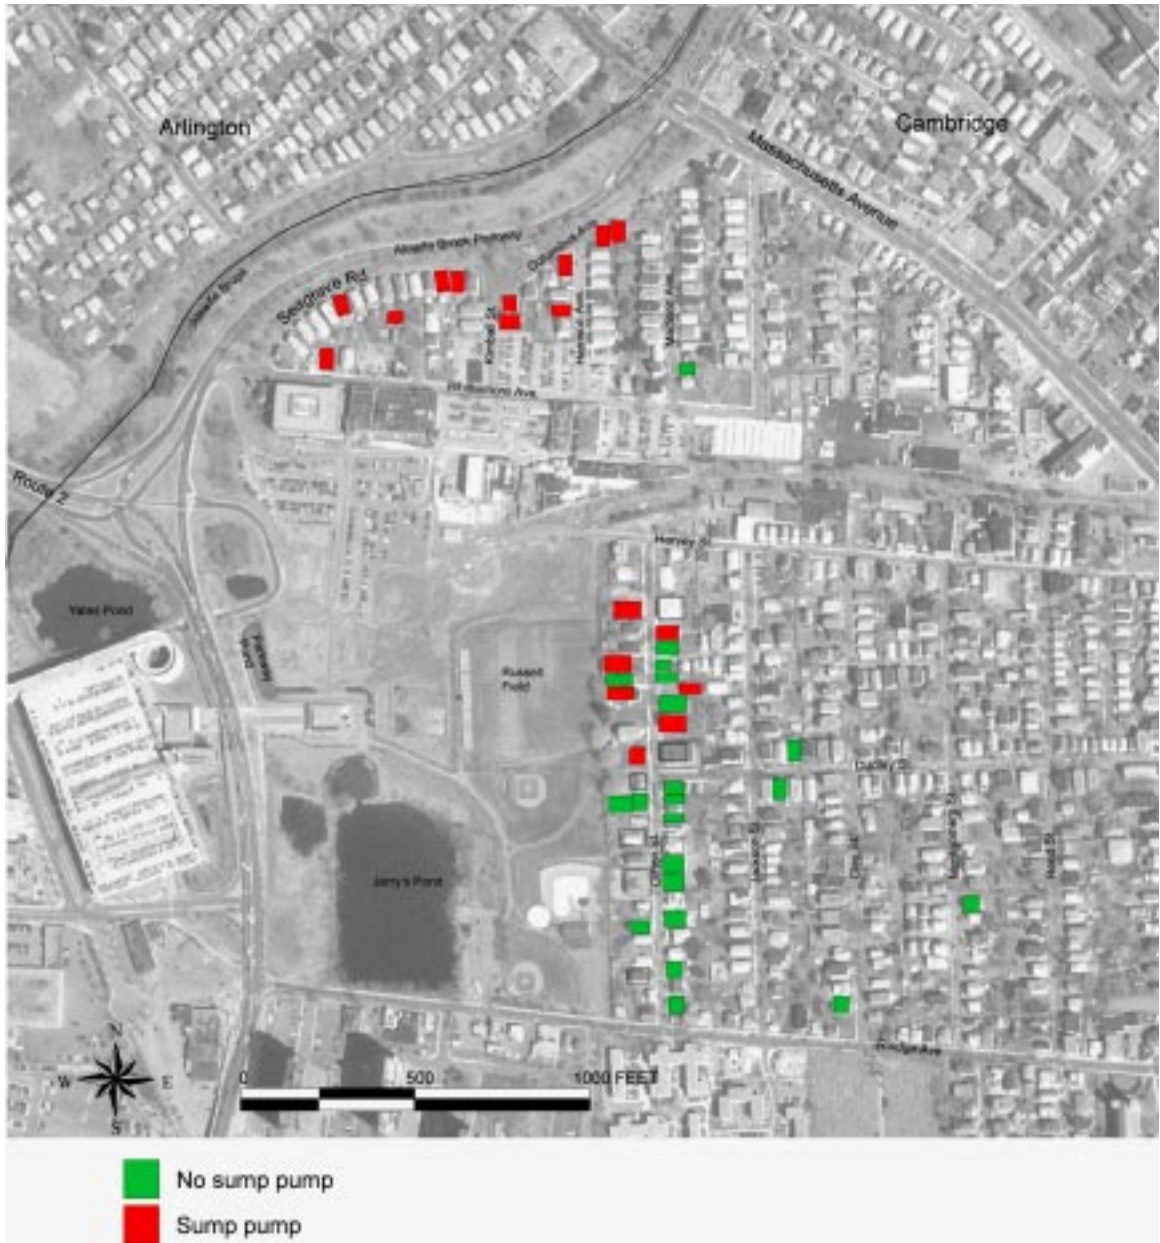
The presence of sump pumps in homes is usually indicative of past flooding. Figure 5 shows the location of surveyed homes with sump pumps. Homes on Whittemore Avenue up to the Alewife Brook Parkway all have sump pumps. Most homes in the north part of Clifton St. along Russell Field have sump pumps, with somewhat lower incidence of sump pumps on the opposite side of Clifton St.. The presence of sump pumps is generally consistent with higher reported flooding frequency as shown in Figure 6.

Figure 5. Surveyed homes with sump pumps.

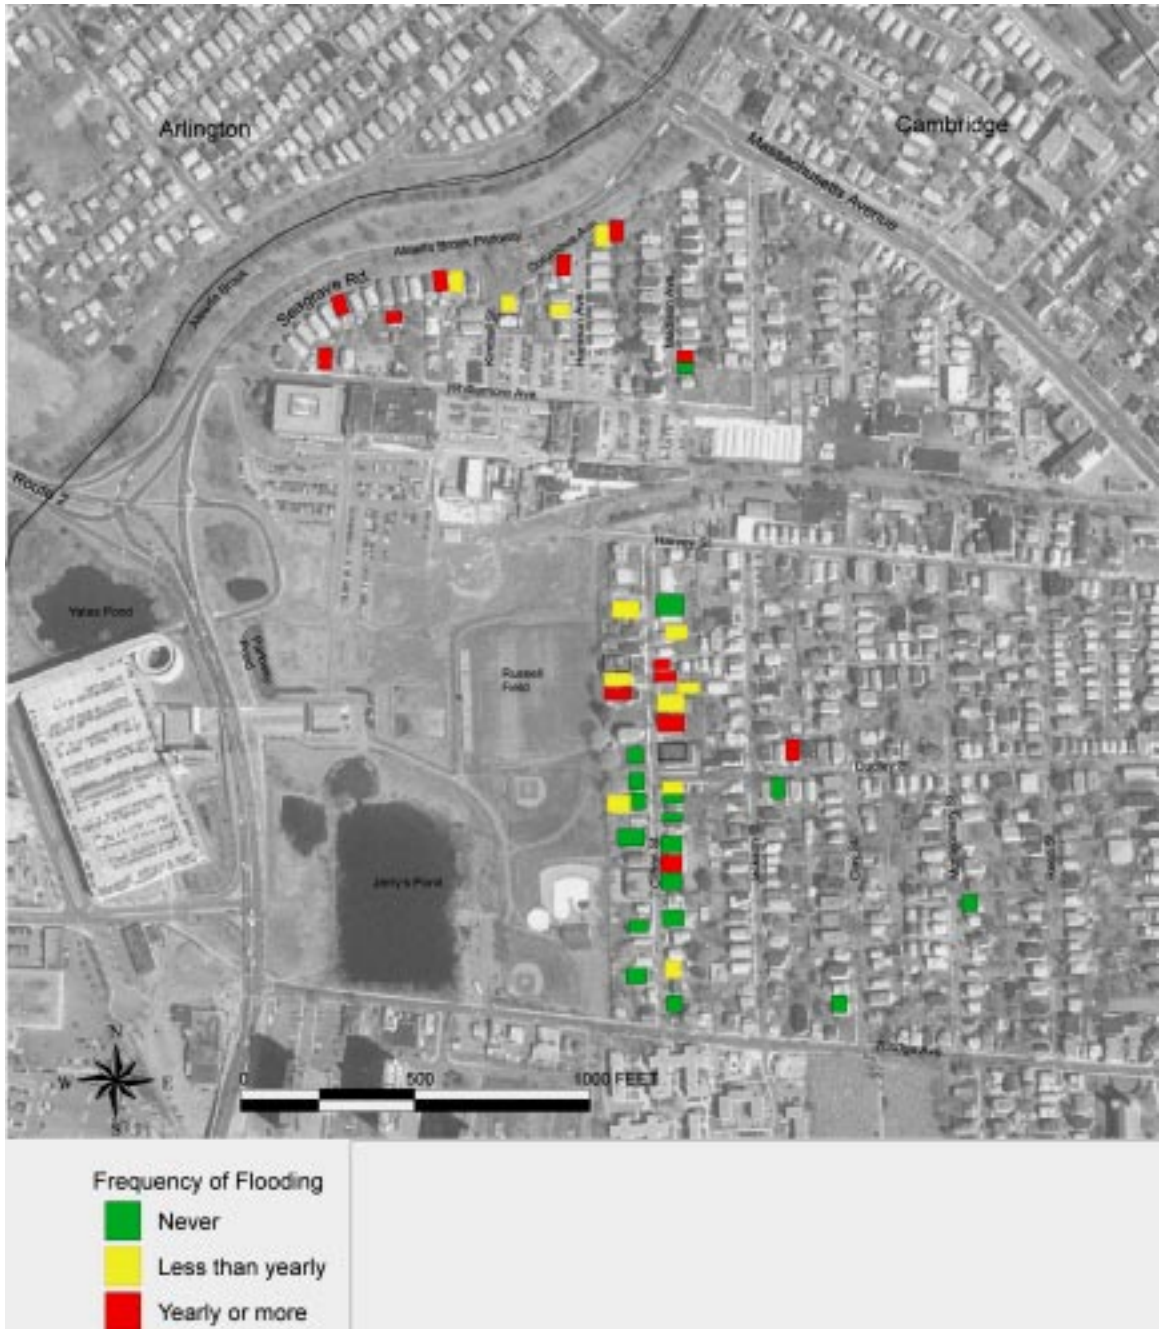
Figure 6. Reported flooding frequency.

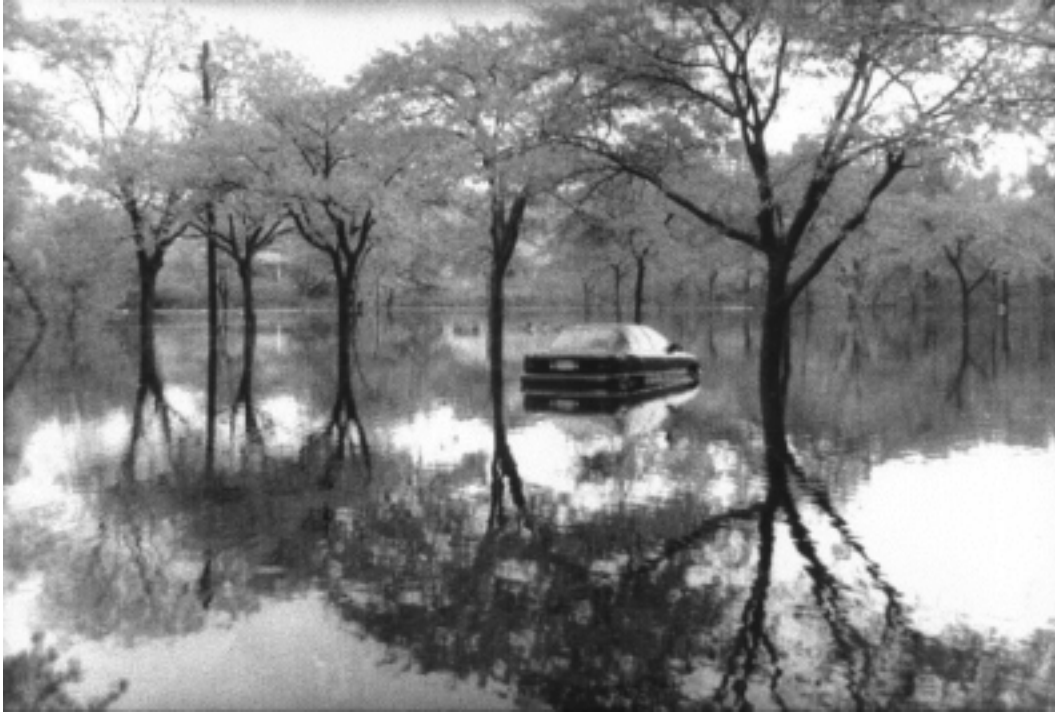
- Route 2 was closed when its low point near Lake Road was inundated under 6 inches of water
- Arthur D. Little offices in the Acorn office park lie at the top of the north bank of the Little River. Waters in the Little River rose over the banks flooding the office basement and the parking lot as shown in Figure 8. This is in contrast to further upstream where the banks of the Alewife Brook were not overtopped.

*Figure 8. Flood conditions during October 1996 storm in Arthur D. Little eastern parking lot on north bank of Little River (by permission of J. Howard).*

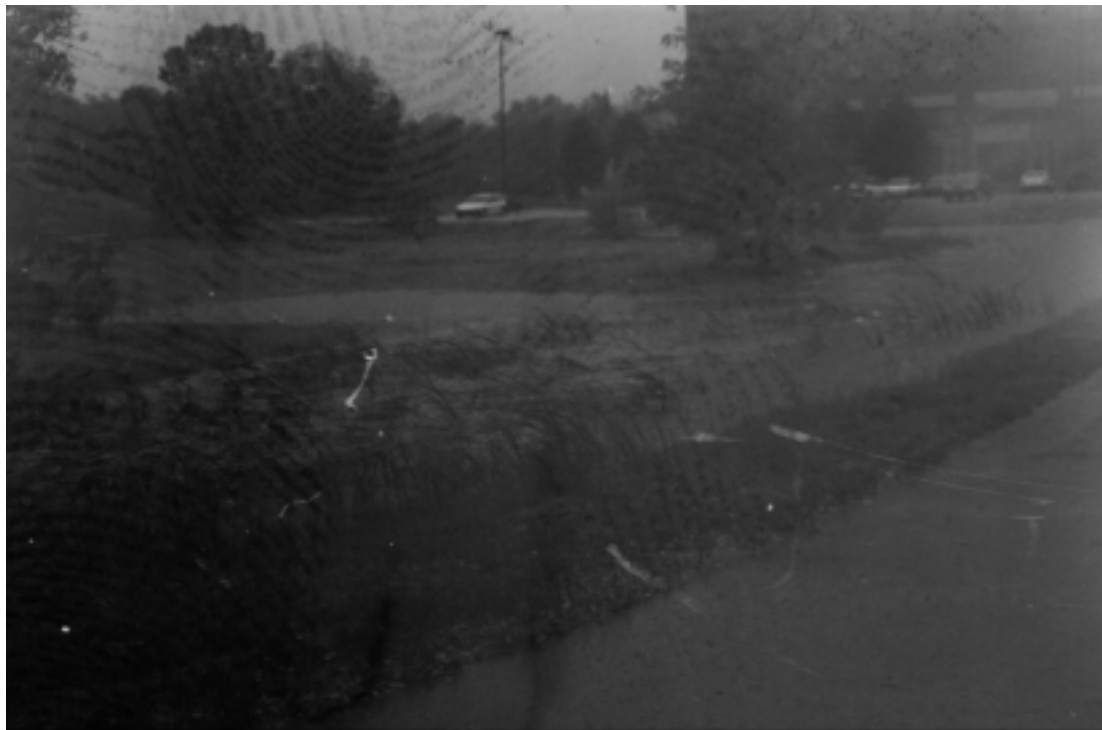
- Low spots south of the existing Alewife Center (Figures 9 and 10) and on Russell Field (Figures 11 and 12) were flooded. Figure 12 shows flooding over the catch basin inside the north gate of Russell Field abutting Clifton St.

*Figure 9. Flooding south of Alewife Center during October 1996 storm.*

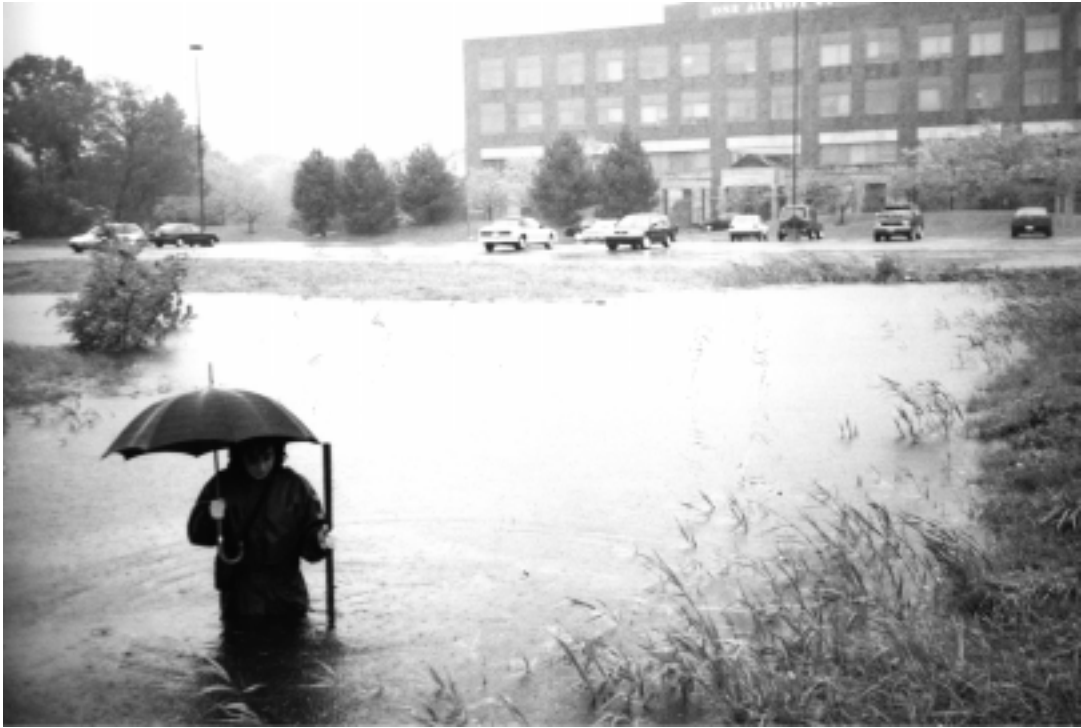
*Figure 10. Flooding south of Alewife Center during October 1996 storm.*

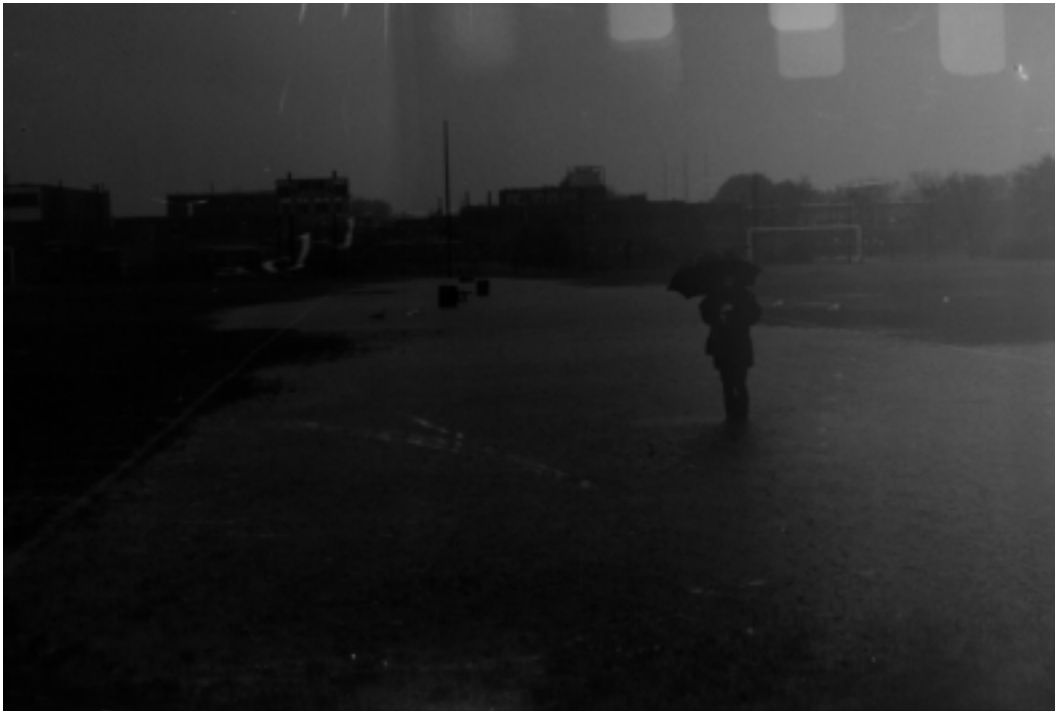
*Figure 11 Flooding in Russell Field during October 1996 storm.*

The eastern half of the soccer field, bordering homes on Clifton Street, drains toward inlets along the eastern side of Russell Field. Survey responses document the presence of flooding in Russell Field behind their homes. Most problematic is the storm drain near the northeast gate of Russell Field. Photographs from the October 1996 storm document knee high flooding and surcharging of this inlet was observed by Jacobs Consulting Services on the evening of September 10, 1999. At the same time, a system of swales connecting ponds on the western edge of the field was observed to be not carrying any significant flows. Alternatives to drainage of any portion of Russell Field toward the Clifton Street homes are available and ought to be explored. This might include regrading Russell Field to drain toward inlets in the center and western side of the field and the construction of swales to convey water to the Parkway Pond / Jerry's Pond swales. Attention should be paid to drainage of sidewalks, which were reported by residences to be frequently ice-covered during the winter months.

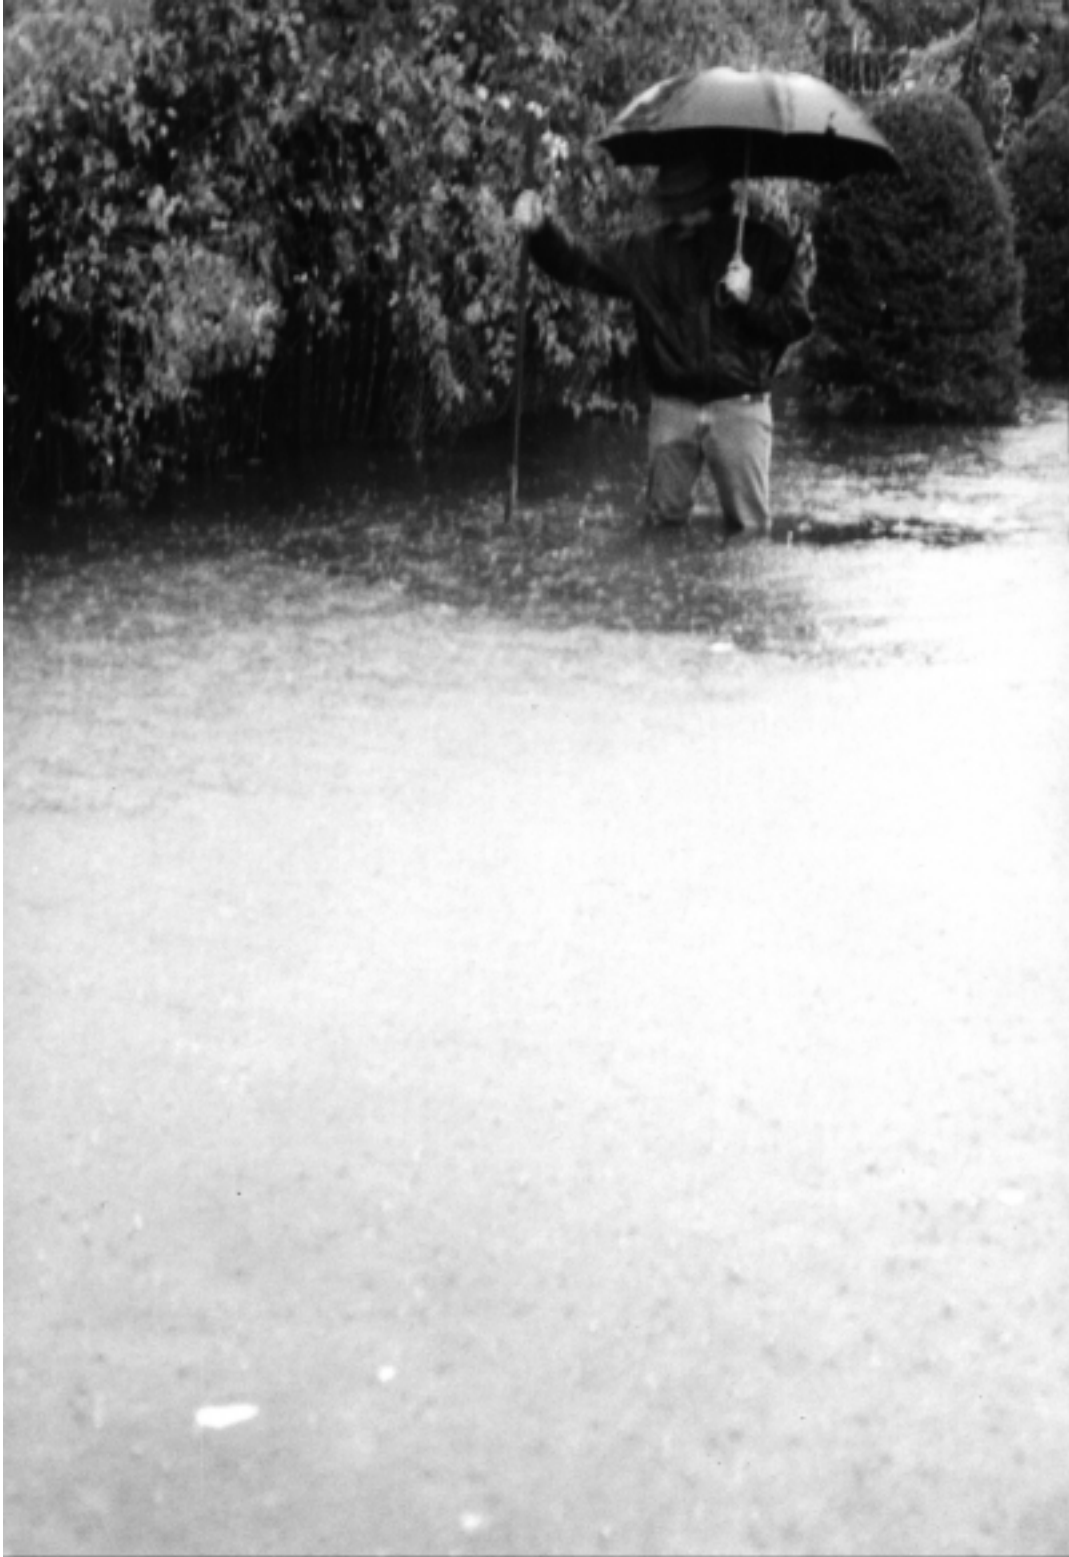
I also observed on the evening of September 10, ponding of approximately one-foot depth at the catch basin near the north gate of Russell Field and the fence line of the Clifton St. properties. Water was observed bubbling out of the storm drain inlet. The source of water was surface drainage from the northeast section of Russell Field. No other significant ponding was apparent on this evening at other points on Russell Field. The storm drain in this area appears to be inadequate to handle the large flows from a good portion of Russell Field.

Flooding of homes on Clifton St. is largely caused by the drainage design on Russell Field, which brings water toward catch basins on the east side of the field. The northernmost of these catch basins was likely inundated as I observed on September 10, 1999. The condition is complicated by catch basins at the intersection of Clifton St. and Dudley St. which by residential accounts and my own personal observation are frequently clogged by debris caught on the catch basin grate. Also, the storm drains along Harvey St. were later found to be obstructed and cleaned out in spring 1999 (personal communication, Owen O'Riordan, Cambridge DPW). Some homes on Clifton St. between Dudley St. and Harvey St. also experience water entering their homes through sink drains, evidently caused by overwhelmed storm drains.

*Figure 12 Flooding at storm drain inlet near northeast gate to Russell Field during October 1996 storm.*

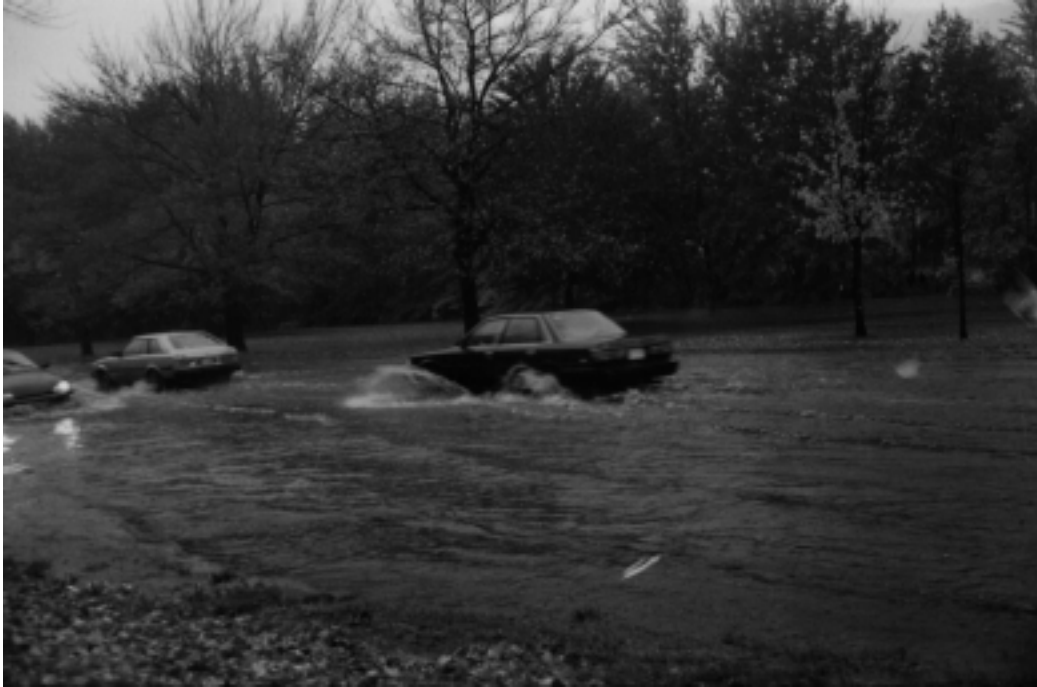
- Alewife Brook Parkway was under water up to the curbs at its low point near the playground (Figure 13). The Brook had not however risen over its banks.

Flooding near Alewife Brook Parkway occurs with some frequency. In storms of the magnitude of the October 1996 storm and lesser storms, the flooding is deepest at the low spot on the Parkway between Massachusetts Ave. and Route 2. Further, the banks of the Alewife Brook on the north side of the Parkway contain water. From photos taken on this date one can see that the banks are not inundated as would be the case if the Alewife Brook were overflowing its banks – as is anticipated in simulations of the 100-year storm event (FEMA, 1981). I have observed that the catch basin at this point opposite Kimball St. does not function even during light events and is likely in part responsible for the frequent flooding along the Parkway. The accumulation of surface water on Columbus Ave. may be partly due to this condition and spill over from the Parkway onto Columbus Ave.

*Figure 13. Surface flooding during October 1996 storm of Alewife Brook Parkway at low point near playground between Massachusetts Ave. and Route 2.*

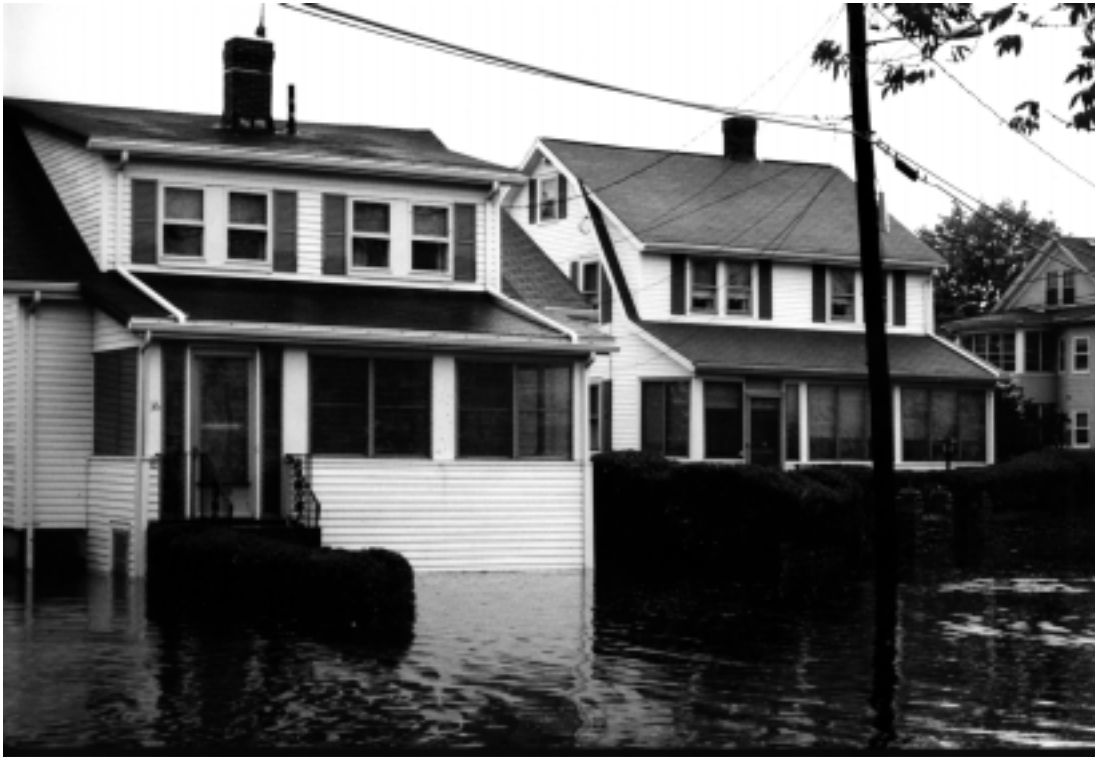
- Water at low points on Columbus Ave. and Whittemore Ave. were present in the road for several days following the rain (Figure 14).
- Flooding at corner of Clifton St. and Dudley Ave. was accompanied by basement flooding in homes near intersection. The likely mechanism in this case is elevated groundwater elevations forcing water through basement walls.

*Figure 14. Surface flooding of Columbus Ave. near playground between Massachusetts Ave. and Route 2.*

An inspection program is recommended to determine whether storm drains on Whittemore Ave., Harrison Ave., Kimball Street and Columbus Ave. are obstructed. Should problems be detected, appropriate actions should be carried out to restore the hydraulic capacity of the storm drains.

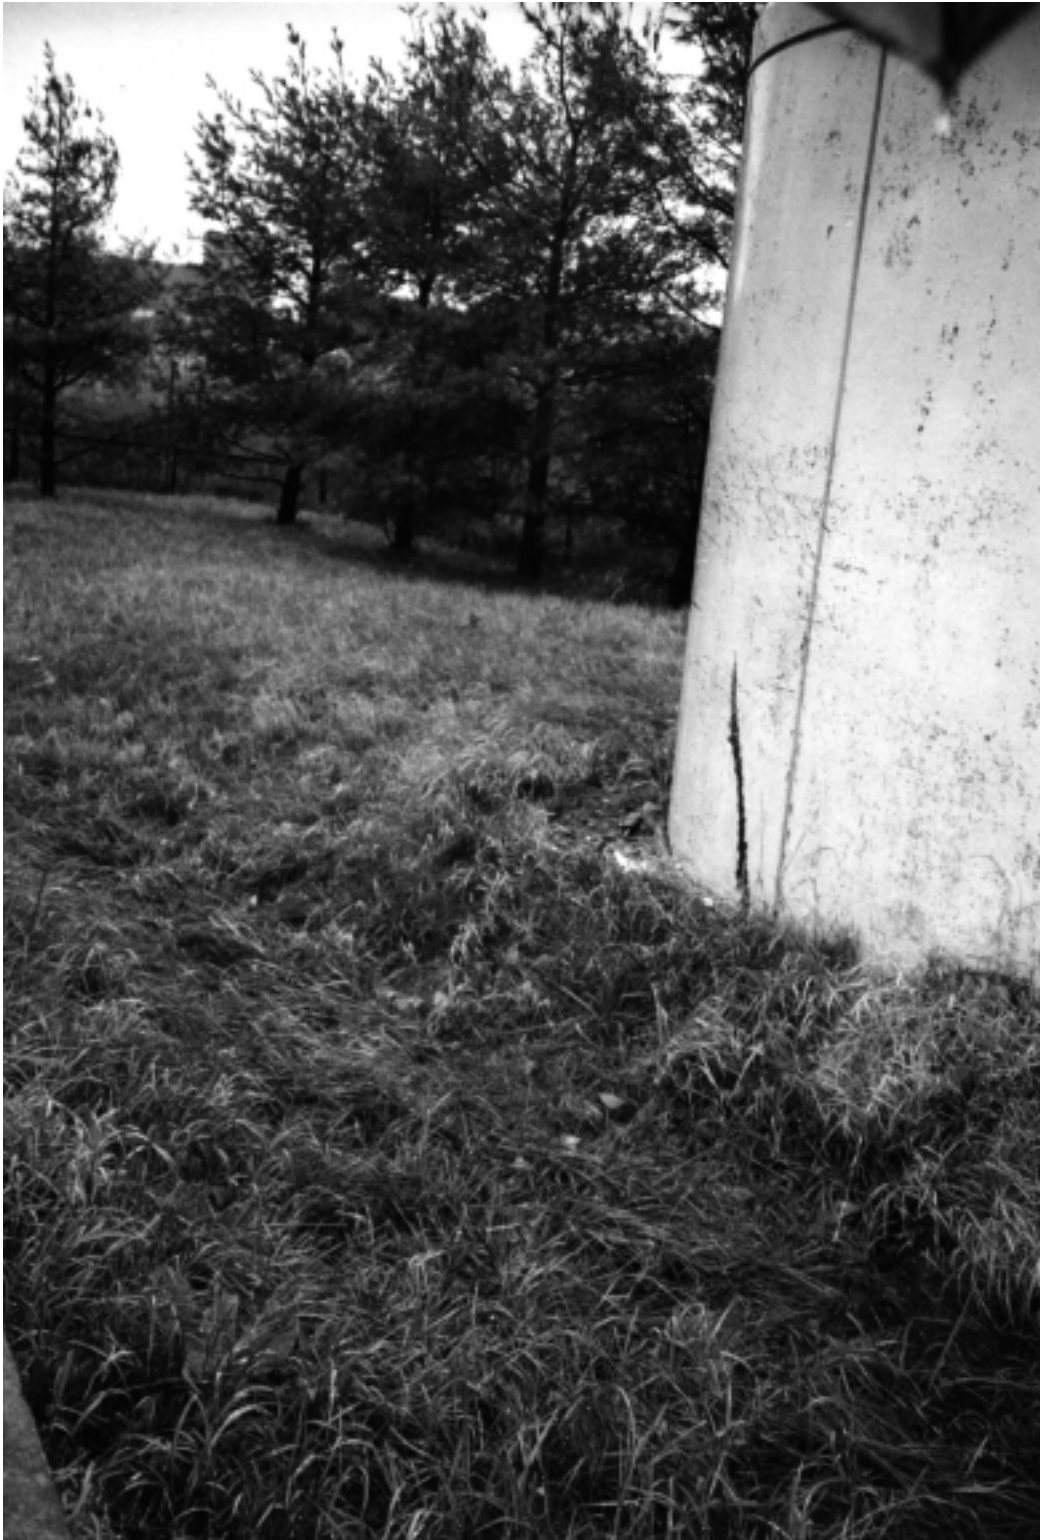
- The drainage swale west of Russell Field, between Parkway Pond and Jerry's Pond, remained dry (Figure 15). The drainage design plans were not made available for our review, however one might expect that the swales ought to be holding or conveying water to Jerry's Pond and Parkway Pond when substantial flooding has occurred over much of Russell Field, neighborhood homes and the Alewife Brook Parkway.

*Figure 15. Swale between Jerry's Pond and Parkway Pond during October 1996 storm.*

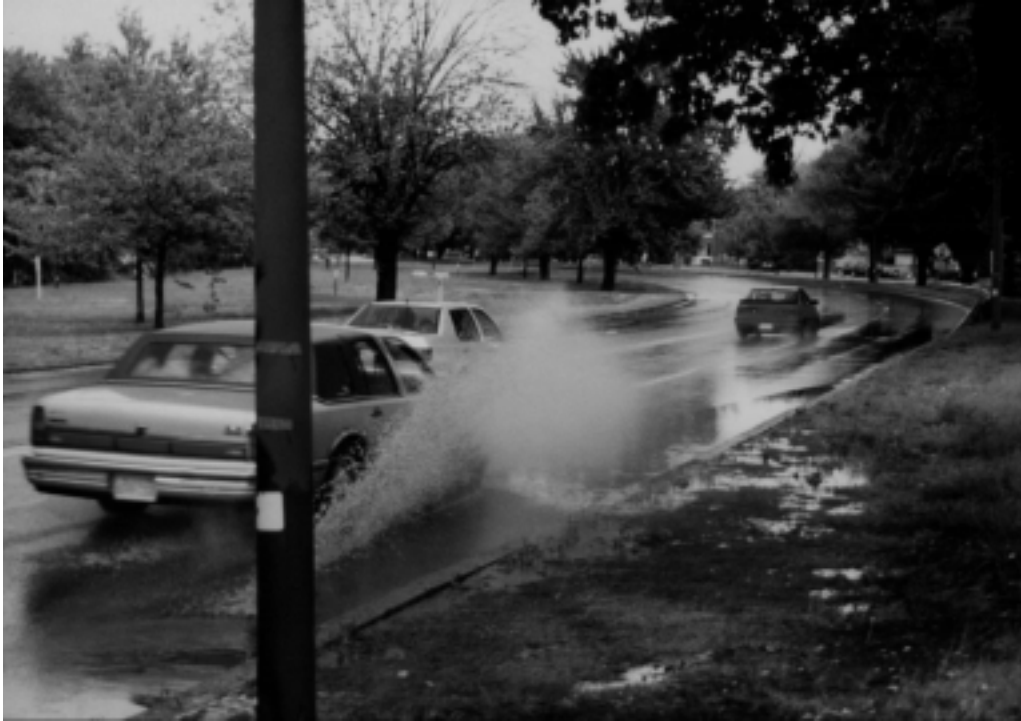
Jacobs Consulting Services performed site visits following a brief shower on September 6 and on the evening of September 10 following a storm of more than four inches of rain. In both cases water had collected up to the curb on the south side of Alewife Brook Parkway near the playground opposite Kimball St (Figure 16). This flooding had occurred despite the presence of a catch basin at this point along the Parkway curb. There was no debris visible on the catch basin, but it was apparent that the catch basin was not functional. This catch basin and the storm drains are owned and maintained by the MDC (Owen O'Riordan, personal communication). Although there was water pooling on the grassy area along Alewife Brook Parkway, the Brook had not overtopped its banks.

Figure 16. Surface flooding of Alewife Brook Parkway between Massachusetts Ave. and Route 2 following brief shower on September 6, 1999.

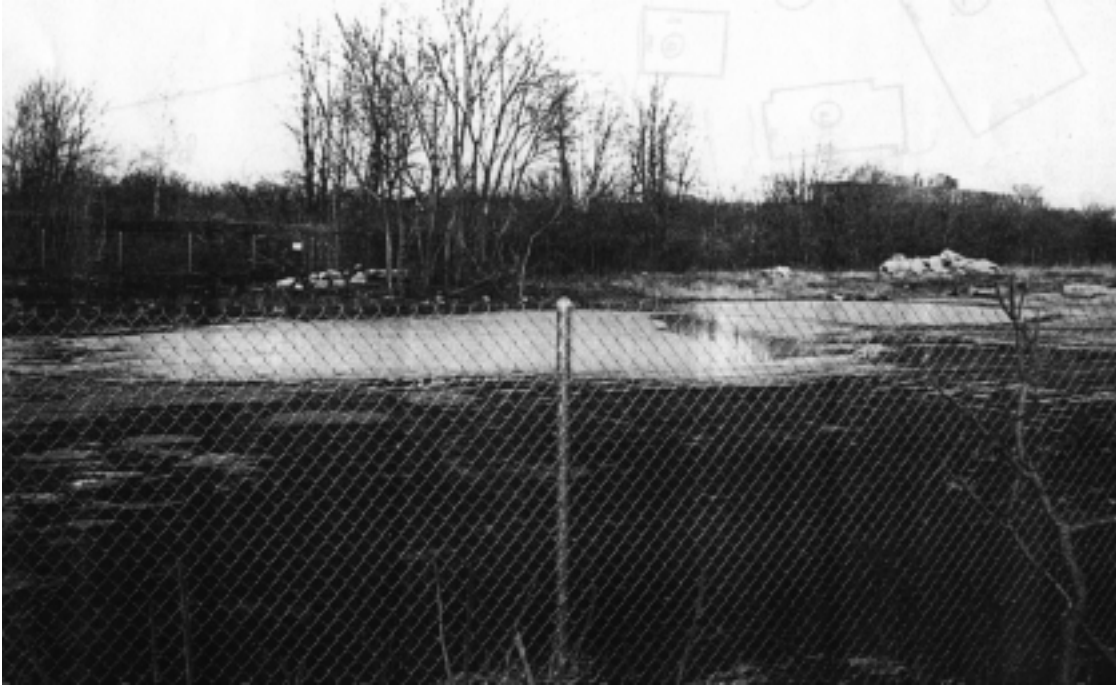
*Figure 18. Depression flood storage during June 1998 storm at 200 Cambridge Park Drive prior to breaking ground for new office building.*

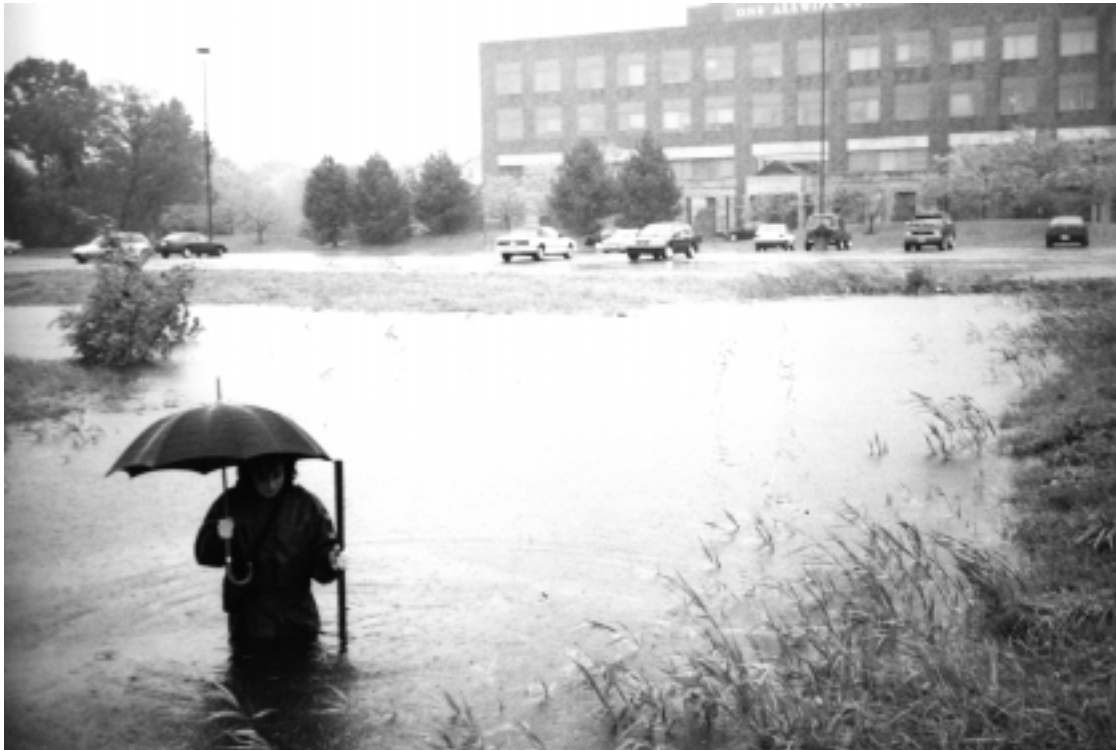
*Figure 19. Depression flood storage during October 1996 storm at site of proposed commercial development abutting Russell Field.*

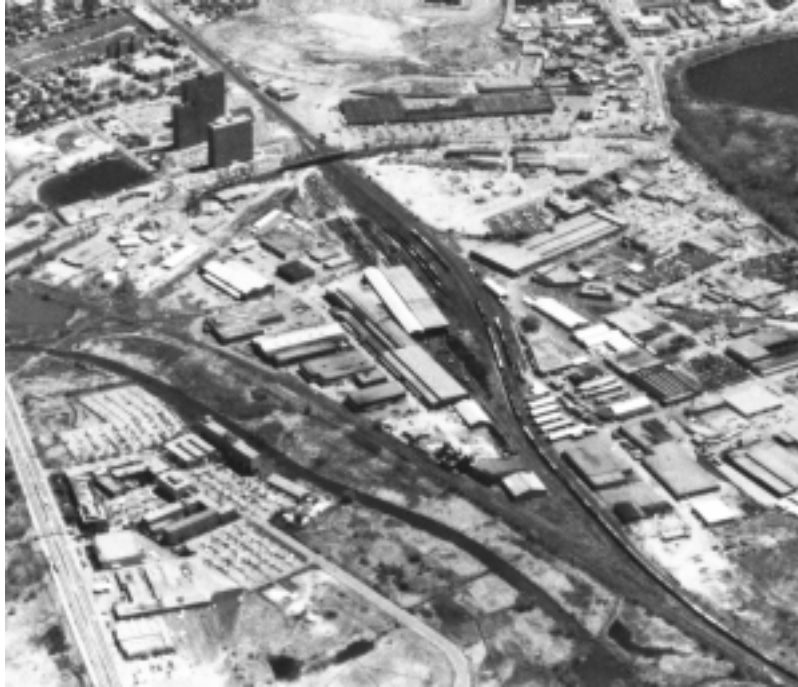
*Figure 20. Aerial photograph of land use along Cambridge Park Drive in 1974.*

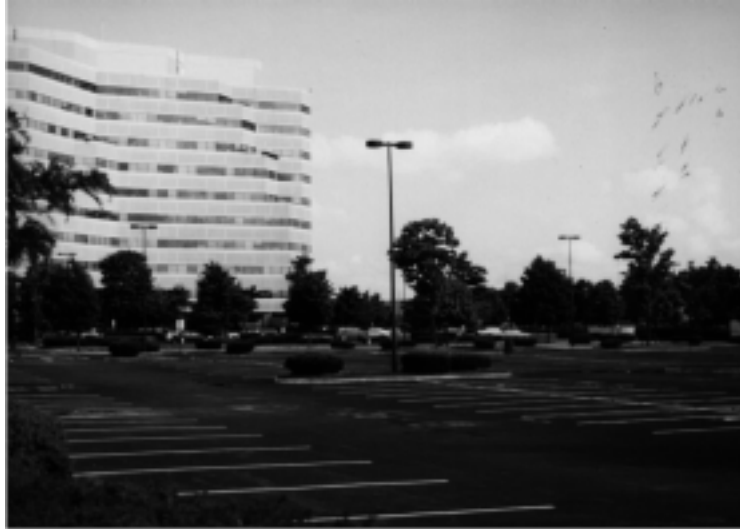
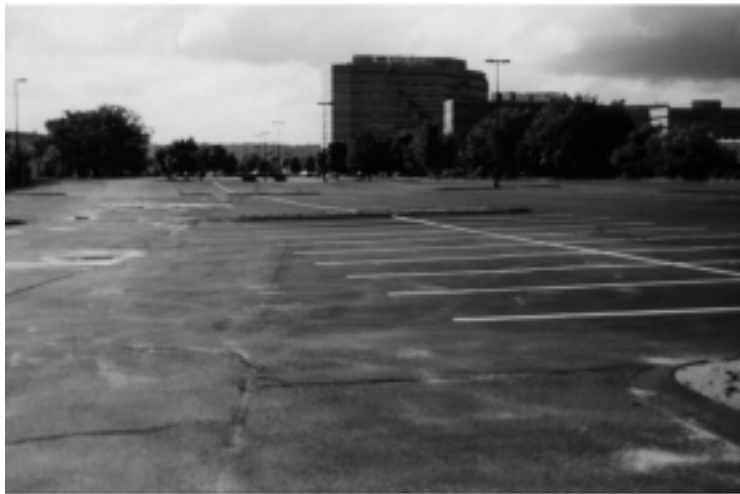
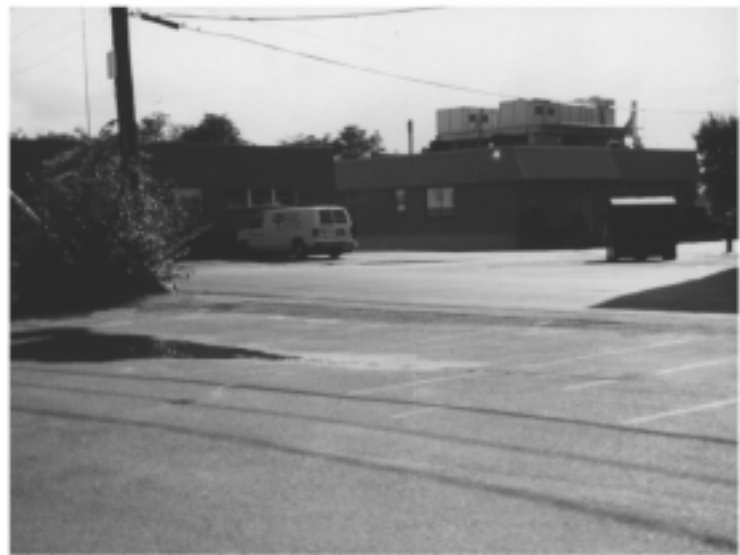
*Figure 21. Contemporary commercial land uses along Cambridge Park Drive.*

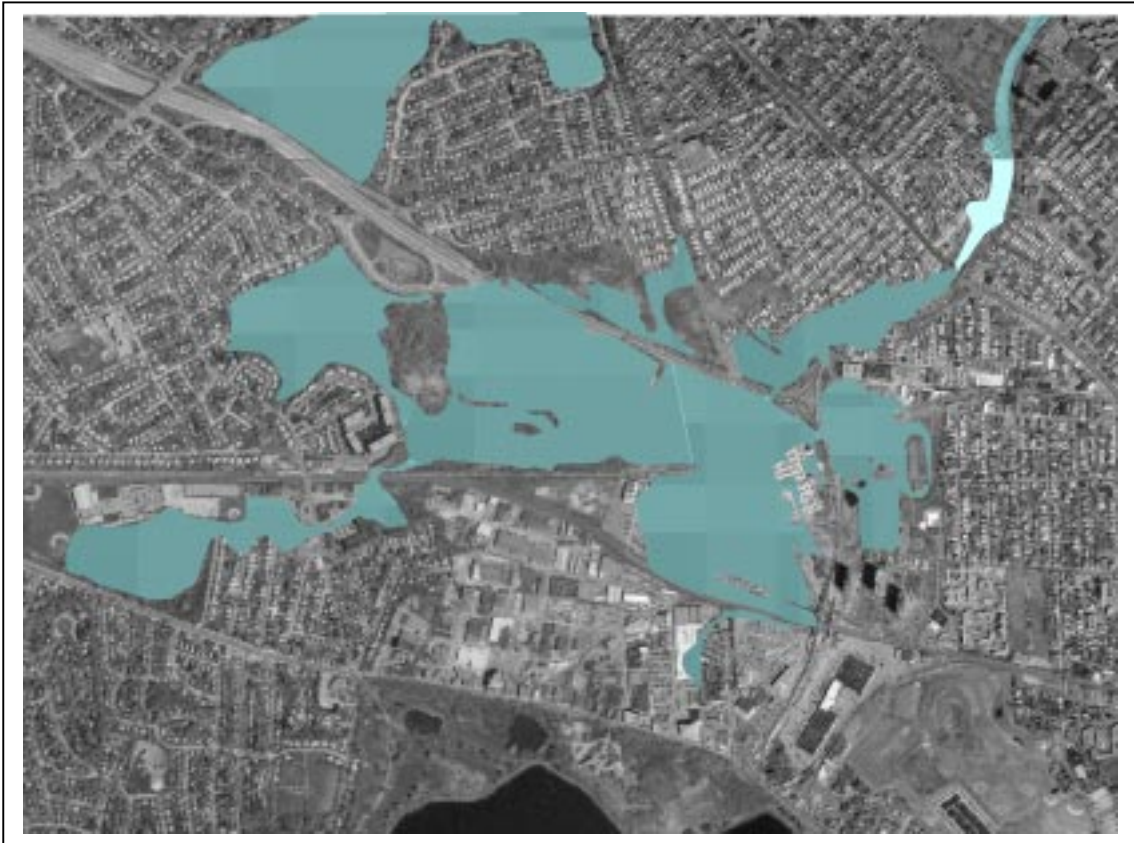
*Figure 22. Estimated bounds of 100-year flood event from FEMA flood insurance map (1982)*

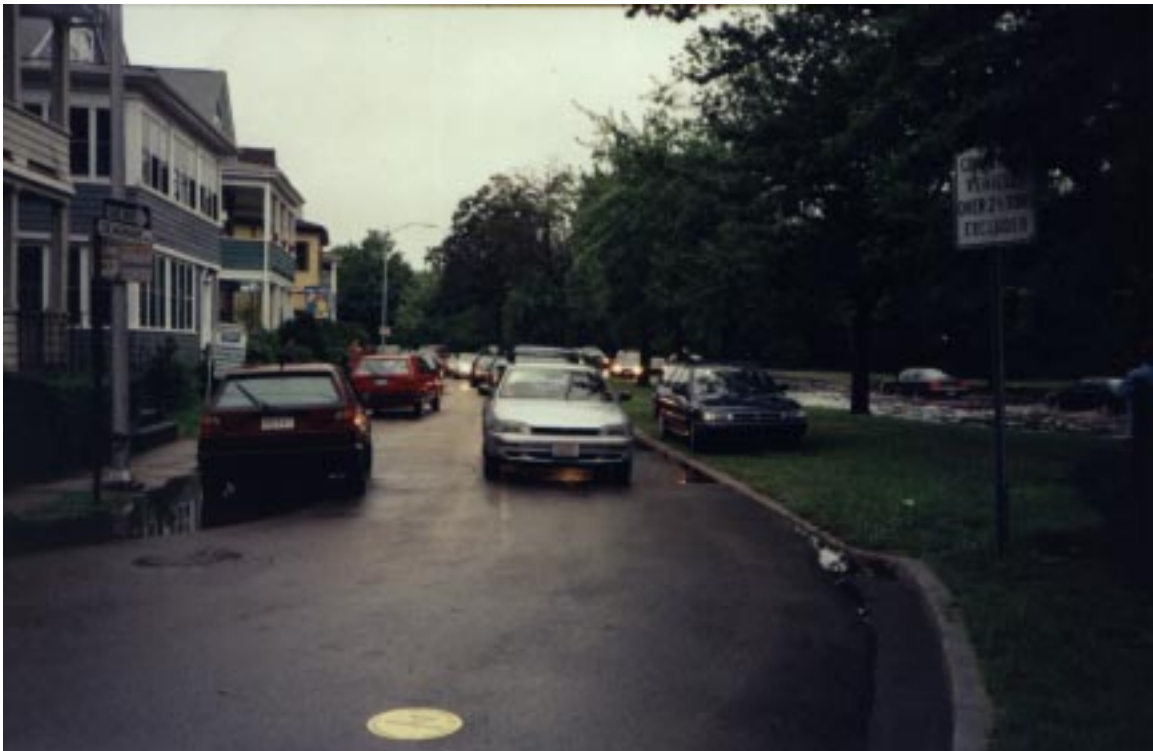
It was reported by Alewife residents that traffic diverted from a flooded Alewife Brook Parkway often ends up on residential streets. This includes the use of Seagrave Ave. opposite to its posted direction, with obvious safety consequences. Figure 23 shows flood conditions on Alewife Brook Parkway and the simultaneous hazardous use of Seagrave Ave.

Figure 23. Flooded Alewife Brook Parkway and cars driving wrong way on Seagrave Ave.
